# *Blue Stains:*

## **Copper Pipe Leaching and Proper Electrical Grounding**

A Case Study from New Mexico

By Peter Ostwald

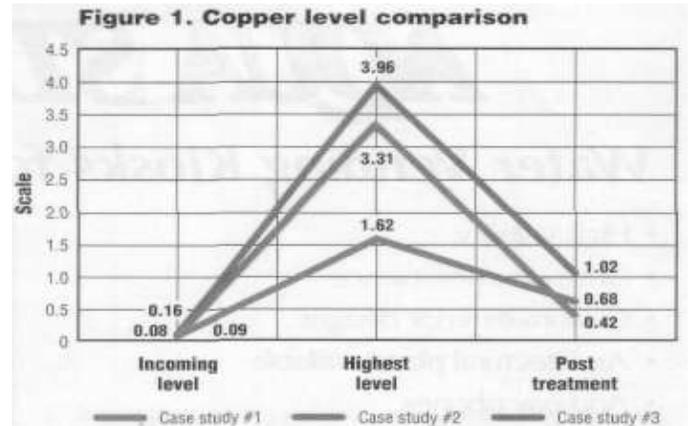
The graph here (see *Figure 1*) shows an increase in the copper levels between the incoming water line at 0.09 ppm and the highest point in the home—the guest bathroom—at 3.31 ppm.

The graph in Figure 1 shows the lab certified copper levels at the following locations:

First—the initial incoming water copper level,

Second—the highest copper level established in the home, before equipment and grounding packages were installed, and

Third—the copper level at the same location after the modifications were made.
